Manhole Inspection Summary

Manhole # S3100_011MH

Location Address: **401 23RD ST**

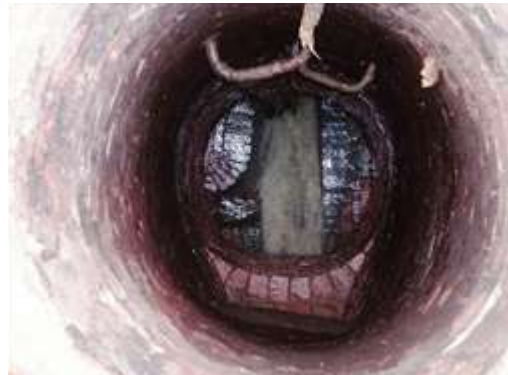
Top View

Corroded and missing steps.

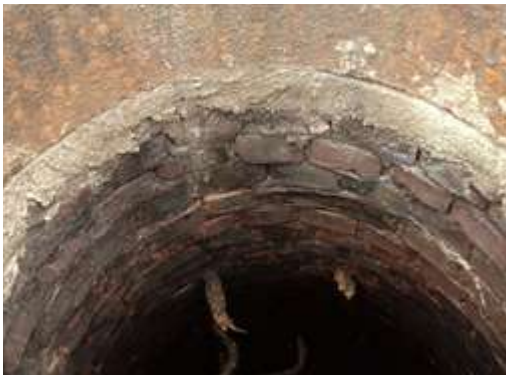
Defect

Frame leaks. Adjustment and Corbel deterioration and infiltration - other side.

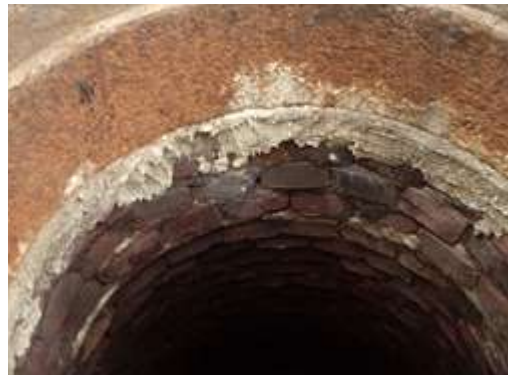
Defect

Adjustment and Corbel deterioration and infiltration.

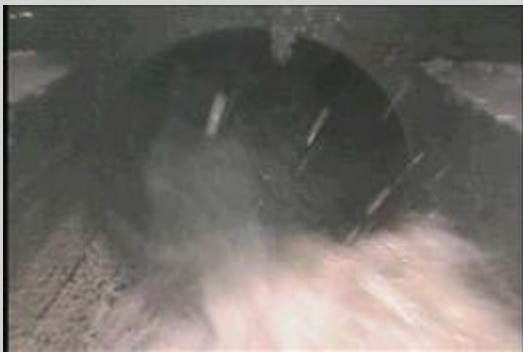
20 in. Circular Gravity Sewer Pipe Out @ 12 O'Clock

Infiltration: **None** Pipe Seal Cond: **Roots**

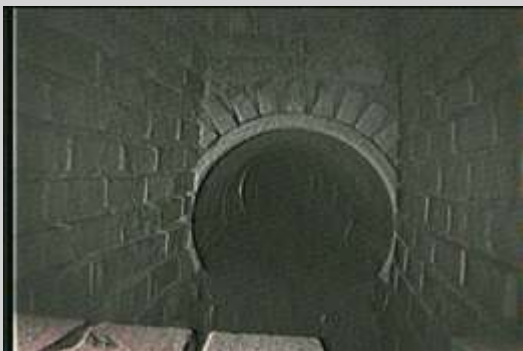
20 in. Circular Gravity Sewer Pipe In @ 6 O'Clock

Infiltration: **None** Pipe Seal Cond: **Cracked**

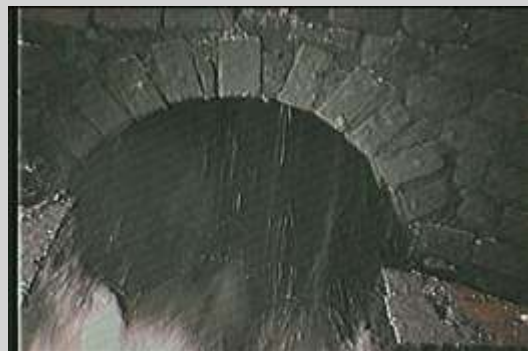
Drop In @ 6 O'Clock

Barrel deterioration and infiltration.
